An investigation into a dropped fuel element incident at Chapelcross Nuclear Power Station

A report by HM Nuclear Installations Inspectorate

*Published by the Health and Safety Executive
February 2002*

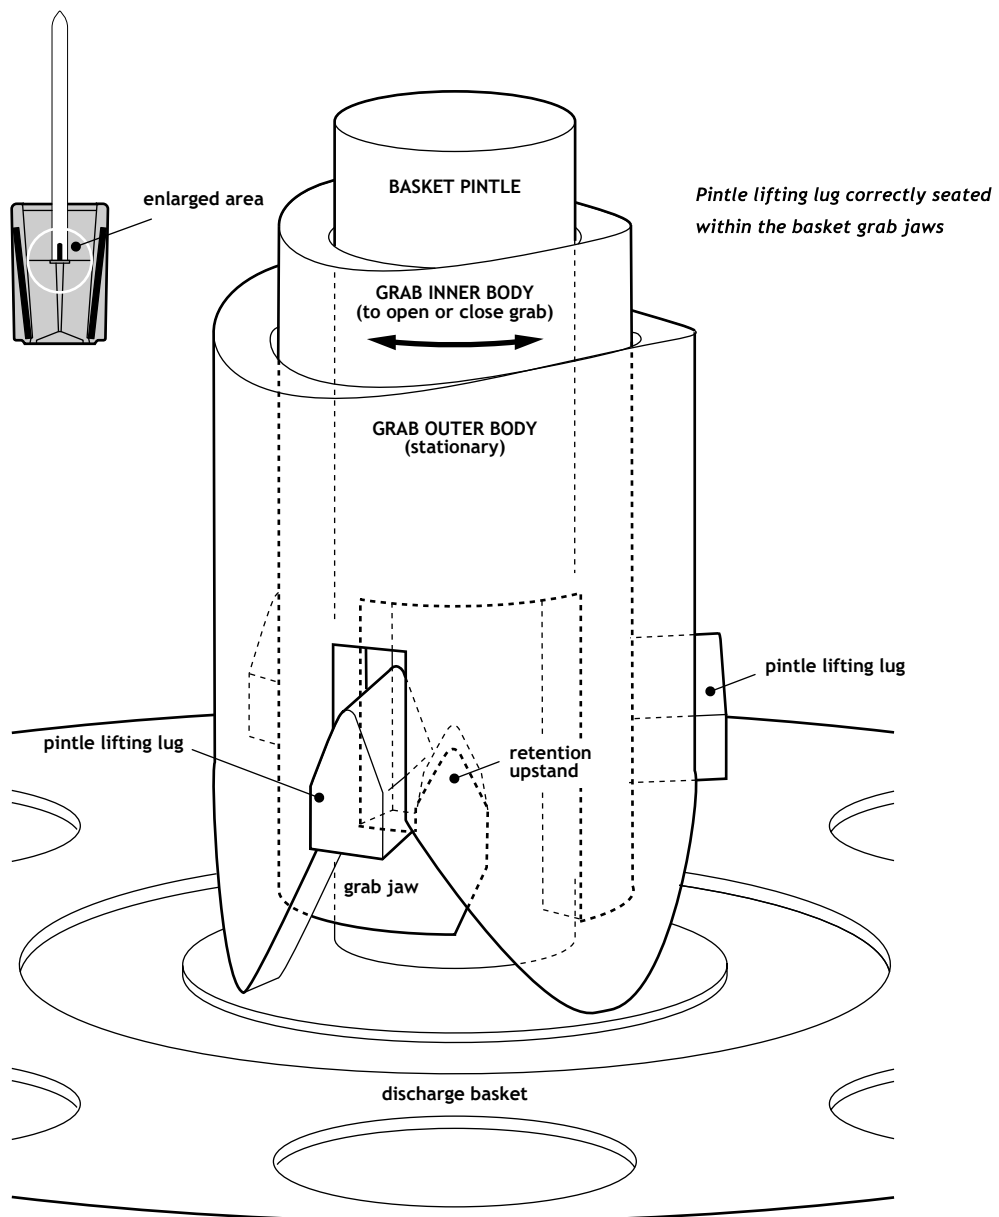
Figure 3: Grab jaws

16. At the start of the process the operator lowers the basket grab down the discharge well onto the top of an empty fuel basket that has been placed at the bottom of the discharge shaft. Once the jaws of the grab are positioned around the lifting lugs of the discharge basket they are electrically driven into a closed position to latch the basket to the hoist. This is achieved by the counter rotation of the inner and outer cylinders. We found that there was no means of ensuring that the jaws properly latch onto the discharge basket pintle lifting lugs. Figure 3 shows the pintle lifting lug correctly seated within the basket grab jaws. Figure 4 shows a simulation of the grab jaws partially open. There is evidence from the as-found condition of the grab assembly to suggest that the jaws may not have been fully closed when the grab was connected to the basket at the start of operations.

17. Subsequent tests carried out by BNFL have shown that during closure of the grab, "spring back" can occur which can result in the jaws not being fully closed. These tests have shown that if there is only 25-50% relative movement between the inner and outer cylinders the discharge basket can still be lifted without the jaws being fully closed. The tests have also shown that there is a critical position where the jaws can spring open under the weight of the discharge basket. It is possible

that if the jaws of the grab had not been fully closed and were close to this critical position a jolt could cause them to spring open and allow the basket to drop.

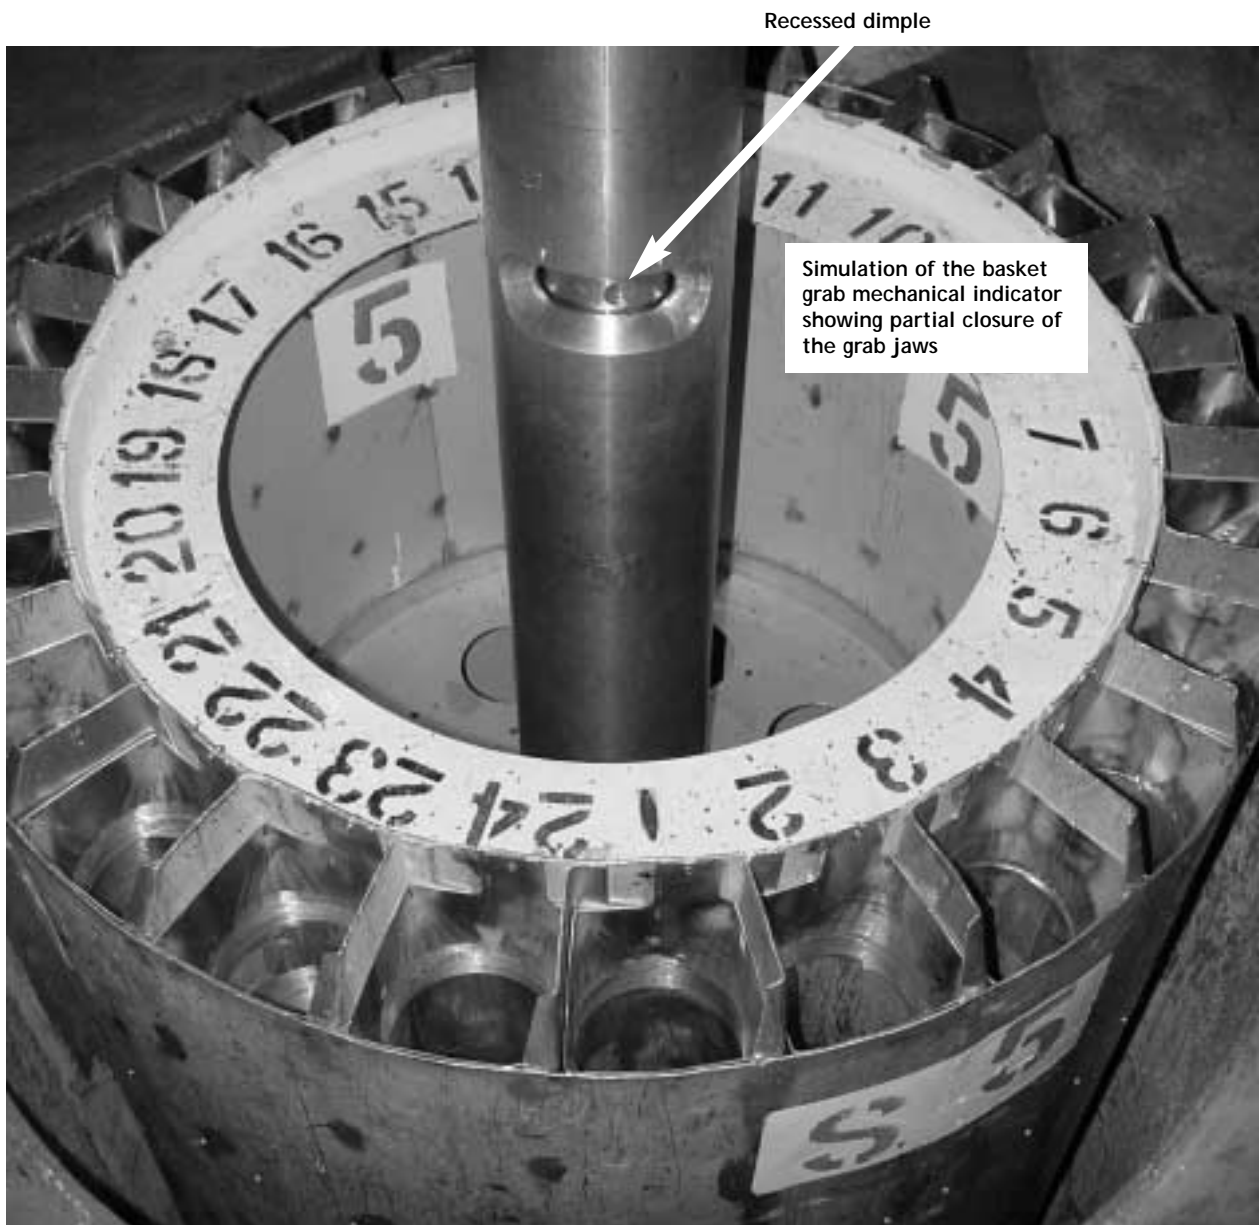
Figure 5: Basket grab mechanical position indicator

18. A mechanical indicator on the basket grab shows the relative position of the two concentric cylinders. The indication is provided by a slot cut into the outer cylinder and a recessed dimple in the surface of the inner cylinder. When the dimple is at one end of the slot the grab jaws are fully open and at the other end they are fully closed (Figure 5).

19. Our investigation found that it is only possible for the operator to attempt to confirm the position of the dimple within the slot, if it is aligned with either a camera mounted inside the discharge chamber (which has very limited capability), or an introscope which again has only a limited field of vision. This alignment with the camera does not routinely happen because the grab assembly is suspended on a long cable and freely rotates as it is raised and lowered. Interlocks prevent the operators entering the discharge chamber and visually confirming that the grab assembly had been correctly connected to the basket.

21. Our investigation concluded that safety would be improved by the installation of additional cameras within the discharge chamber to enable the operator to check and confirm that the basket grab is correctly latched before attempting to raise the basket up the discharge well.

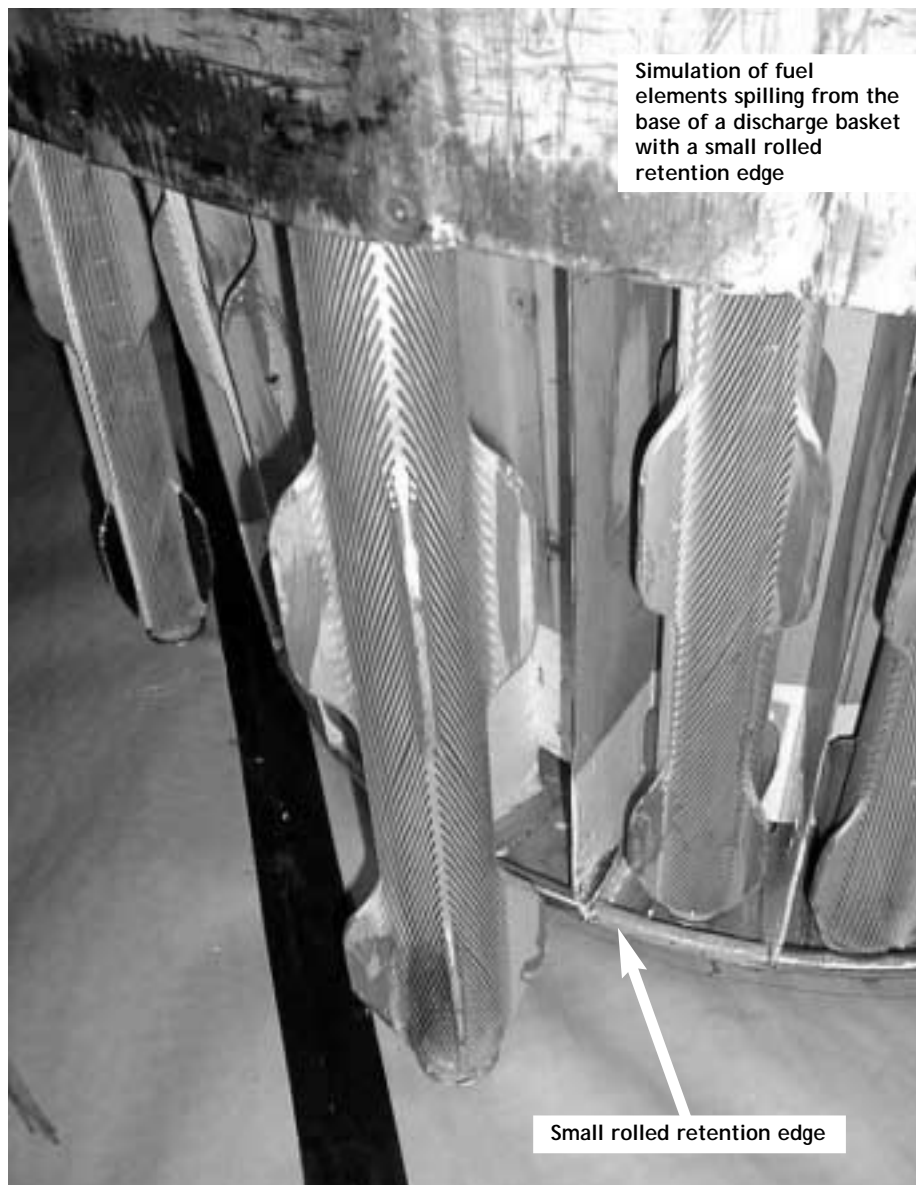
Figure 7: Fuel elements inside discharge basket

33. Our investigation also found that the discharge basket being used at the time of the incident only had a small rolled edge at its base which provided limited retention capability (Figure 7). This would not have been sufficient to prevent fuel

elements from jumping out of their recess as a result of the impact load from the basket striking the door of the hoist well. We conclude that this type of discharge basket should be withdrawn from service.
